Test Report

Report No.: KN-2409-1729-2

Applicant Company:	Ningbo Langchi New Materials Technology Co., Ltd.	
Address:	No. 59 Lixin Road, Zonghan Street, Cixi City, Zhe province	jiang
Attn:	Huang Kang	
Sample:	FEP Gas Pipe	
OEM:		
Model:		
Car Model:	1	
Part No.:		
Material:		
Date Produced:		
Date of Sample Received:	Sep.23, 2024	
Date of Testing:	Sep.24, 2024~Sep.26, 2024	
Date of Report Released:	Sep.26, 2024	
Shanghai KUIEN Technical Te	sting Service Co., LTD	
Reporter / Main testing:	Verifier: Approver:	
Bell Liu	Beryl Luo Landy Luan	1
Date: Sep.26, 2024	Date: Sep.26, 2024 Date: Sep.26, 2024	+

Shanghai KUIEN Technical Testing Service Co., LTD

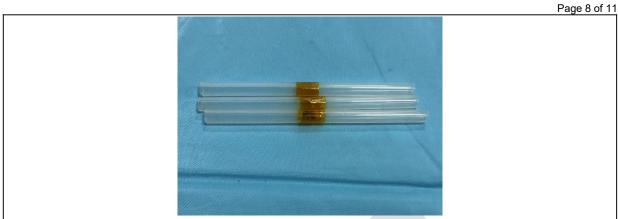
After Test

2. State after heating:					
	NO.	Result				
	1#	After the test, there are no cracks and color changes.				
	2#	After the test, there are no cracks and color changes.

3#	After the test, there are no cracks and color changes.		
	Evaluation	Pass		
Test Instruments	Equipment No.	Equipment Name	Calibration Due Date	
	KN-SH-EQ-054	Electric blast drying oven	2025.01.31	
	KN-SH-EQ-215	Digital display vernier caliper	2025.08.25

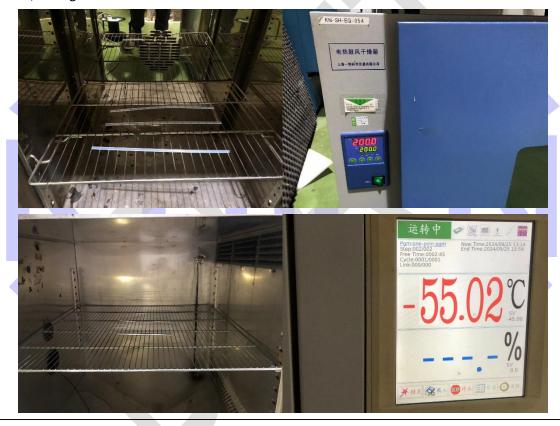
Test Set/During Test

KN-2409-1729- 2.003	Low temperature fle	exibili	ty	Page 9 of 1	
Ref. Specs Section	QBT 4883-2015 chapter 4.3				
Date Tested	2024.09.24~2024.09	.26	_		
Sample No.	1#, 2#, 3#.				
Test Method	The three samples with a length of 300 mm were placed in the oven at $(200\pm2)^{\circ}$ C for 5 h. Next the samples were taken out and cooled to room temperature. Then the samples and the 9.5mm diameter mandrel were placed in the temperature chamber at $(-55\pm2)^{\circ}$ C for 4 h. Finally the samples were quickly tested at $(-55\pm2)^{\circ}$ C

2)°C.The samples should be wound on the mandrel at least 2 times, and the winding speed is approximately 2 S per turn. Remove the samples from the temperature chamber to check for cracking after the test.				
Acceptance Criteria	After the test, the sa	mple	s should not crack.		
Deviation	1				
Test Results	NO.		Result		
	1#	After the test, the samples have not cracked.			
	2#		After the test, the samples h	ave not cracked.	
	3#		After the test, the samples h	ave not cracked.	
	Evaluation		Pass		
Test	Equipment No.		Equipment Name	Calibration Due Date	
Instruments	KN-SH-EQ-054		Electric blast drying oven	2025.01.31	
	KN-SH-EQ-087		Constant temperature and humidity chamber	2025.03.01	
Observations & None	Remarks				
<u>Pictures</u> Before Test
