# Test Report

Report No.: KN-2409-1729-2

**Applicant Company:** Ningbo Langchi New Materials Technology Co., Ltd.  
**Address:** No. 59 Lixin Road, Zonghan Street, Cixi City, Zhejiang province  
**Attn:** Huang Kang  
**Sample:** FEP Gas Pipe  
**OEM:** /  
**Model:** /  
**Car Model:** /  
**Part No.:** /  
**Material:** /  
**Date Produced:** /  
**Date of Sample Received:** Sep.23, 2024  
**Date of Testing:** Sep.24, 2024~Sep.26, 2024  
**Date of Report Released:** Sep.26, 2024  
**Shanghai KUIEN Technical Testing Service Co., LTD**

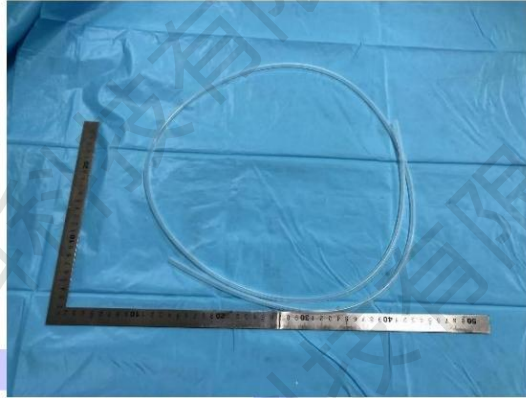
**Pictures**

| KN-2409-1729-2.001 | | Size | | |
| Test Method | <p>According to GB/T 2918-1998, the sample was subjected to state adjustment for at least 4 h under the condition of temperature of <math>(23\pm 2)^{\circ}\text{C}</math> and relative humidity of <math>(50\pm 10)\%</math>, and the size was measured under this condition.</p> <p>1. Inner diameter deviation: The plug gauge corresponding to the inner diameter of FEP pipe is used for measurement, the accuracy of the plug gauge is not less than 0.02mm, and the inner diameter deviation is the difference between the measured inner diameter and the nominal inner diameter.</p> <p>2. Wall thickness: According to GB/T 8806-2008, the maximum and minimum wall thickness are measured.</p> | | | |
| | Inner diameter | 3.97mm | -0.03mm | Pass |
| | Maximum wall thickness | 1.02mm | 0.02mm | Pass |
| | Minimum wall thickness | 0.97mm | -0.03mm | Pass |

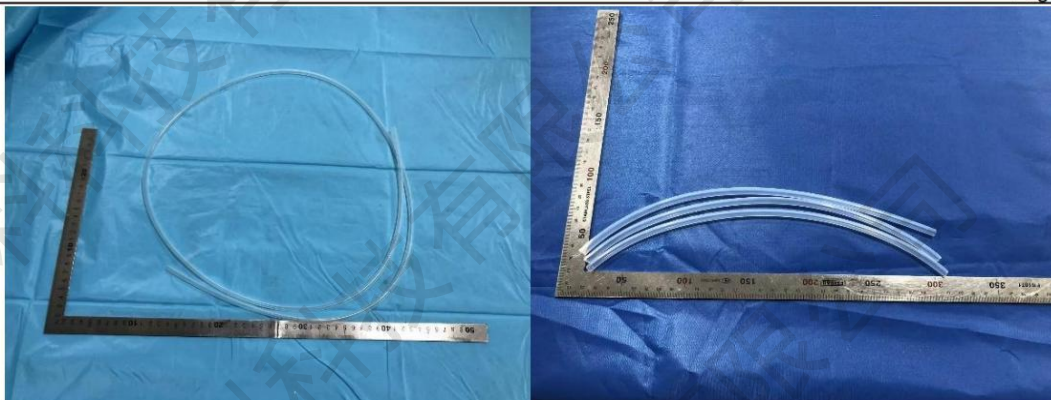
| Test Method | | The three samples with a length of 300 mm were placed in the oven at $(200\pm 2)^{\circ}\text{C}$ for 5 h. Next the samples were taken out and cooled to room temperature. Then the samples and the 9.5mm diameter mandrel were placed in the temperature chamber at $(-55\pm 2)^{\circ}\text{C}$ for 4 h. Finally the samples were quickly tested at $(-55\pm 2)^{\circ}\text{C}$ . The samples should be wound on the mandrel at least 2 times, and the winding speed is approximately 2 S per turn. Remove the samples from the temperature chamber to check for cracking after the test. | |

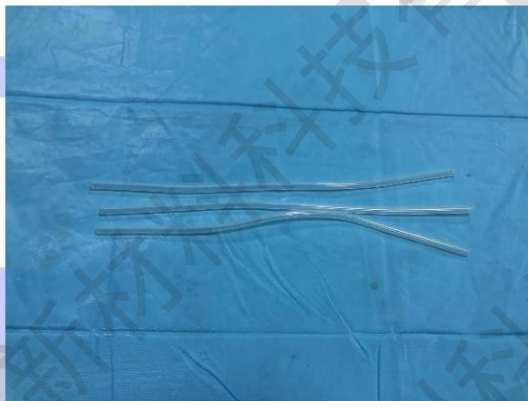
After Test

| | 1# | After the test, the samples have not cracked. | |
| | 2# | After the test, the samples have not cracked. | |
| | 3# | After the test, the samples have not cracked. | |
